FLIR GF306 helps improve environmental performance at Scottish and Southern Energy Power Distribution

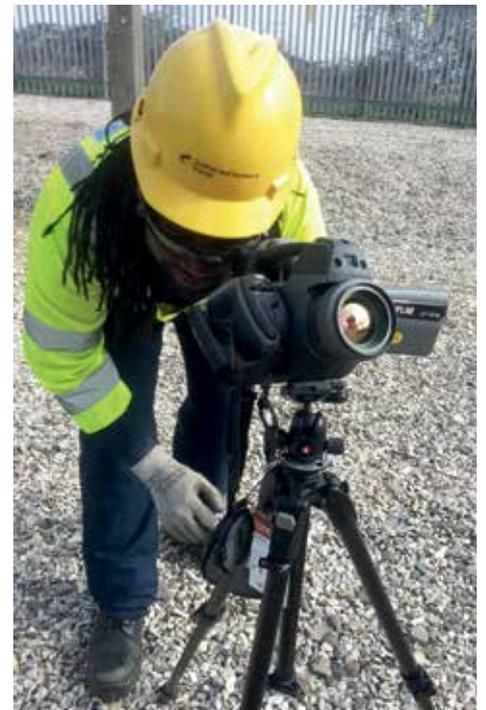
The GF306 has a highly sensitive detector that is specifically designed to visualize SF₆ gases.

selection process, SSEPD decided to purchase two GF306 cameras from FLIR. The GF306 has a highly sensitive detector that is specifically designed to visualize SF6 gas.

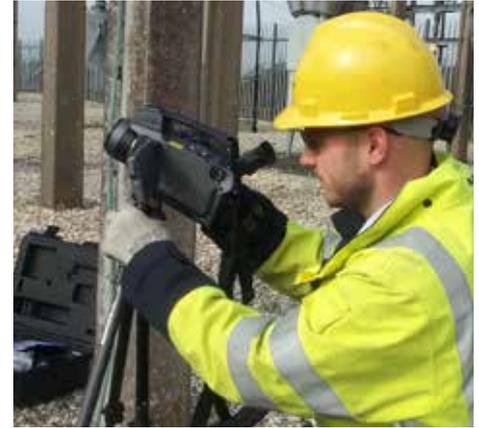
With the GF306, you can look at the switch gear equipment from a safe distance.

"The FLIR cameras allowed us to work in a totally different and more efficient way," says Mr. Chitifa. "With the GF306 camera, you can look at the switch gear equipment from a safe distance, allowing you to cover a wider area. At the same time, the thermal imaging camera allows you to exactly pinpoint where the leak is, up to the actual source. Even very small leaks can be detected clearly. This has proved to be invaluable and saved us a lot of time."

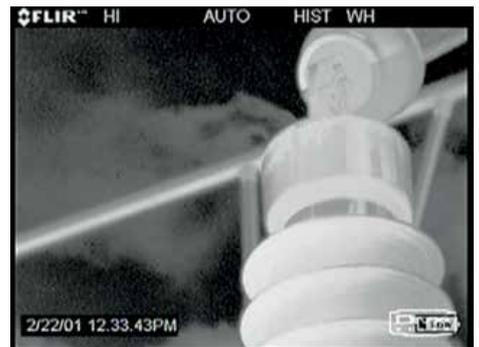
During their first FLIR training course, SSEPD identified a leak on a recently installed high-voltage circuit breaker.

In December 2013, SSEPD purchased two GF306 cameras. The investment quickly provided return. "We attended training courses organized by FLIR Systems to better learn the benefits and operation of the thermal imaging camera. During the first FLIR training course, we took the camera out in the field and identified a leak on a recently installed high-voltage circuit breaker. Talk about return on investment!"

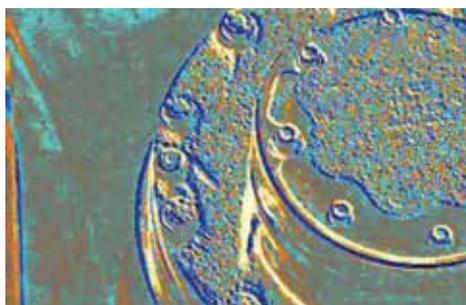
High Sensitivity Mode (HSM) - Reference US Patent US7649174

which is included in all GF-Series optical gas imaging cameras. It is an image subtraction video processing technique that effectively enhances the thermal sensitivity of the camera. The HSM feature subtracts a percentage of individual pixel signals from frames in the video stream from the subsequent frames, thus enhancing the differences between frames, which make leaks stand out more clearly in the resulting images.

"To have the most reliable detection results, we make sure we capture the leak in different image modes: the IR image, the HSM mode and the visual image. This way, we are sure we don't miss out on anything and we can provide a reliable briefing to anyone who needs to repair the leak."
