## Thermal alarm system ensures children's safety at Istanbul Sabiha Gökçen Airport

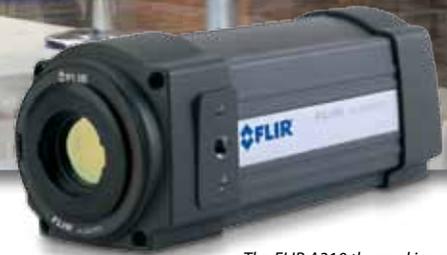
The FLIR A310 thermal imaging cameras ensure that the conveyor belts stop automatically.

The safety system consists of four FLIR A310 thermal imaging cameras, each covering two conveyor belts leading from the check in area to the baggage handling system. For each thermal imaging camera four regions of interest (ROI's) are defined. A temperature threshold is determined at around 31 °C. For the alarm to go off, however, it is not enough for a small part of the ROI to reach a temperature above the threshold. Over a certain percentage (about 20%) of the area in the thermal image that is defined as a ROI needs to be above the threshold for the alarm to go off.

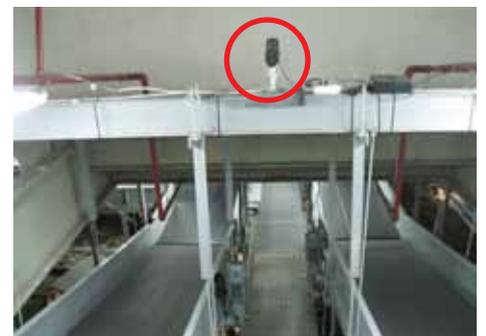
Due to the wide angle lens one FLIR A310 thermal imaging camera can cover two conveyor belts.

us, since the wide angle lens allows us to monitor two conveyor belts with one camera. The digital outputs allow the system to automatically shut down the conveyor belt if an alarm is triggered. Lastly the software that FLIR provides, FLIR IR Monitor, is

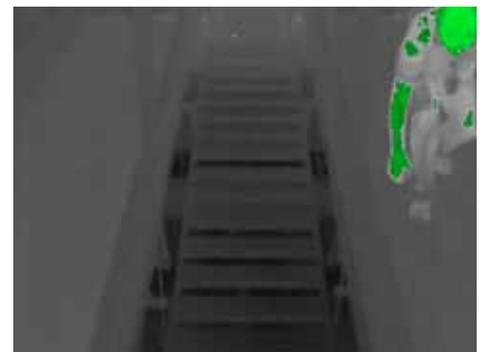
Field tests have shown that if a person enters the conveyor belt area the automatic temperature alarm will immediately stop the conveyor belt system.

"We have performed a lot of tests and this system works really well", explains Kaan Türkmen. "Several of our own employees have climbed into the baggage system to simulate the situation where a child climbs onto the conveyor belt and as it turns out

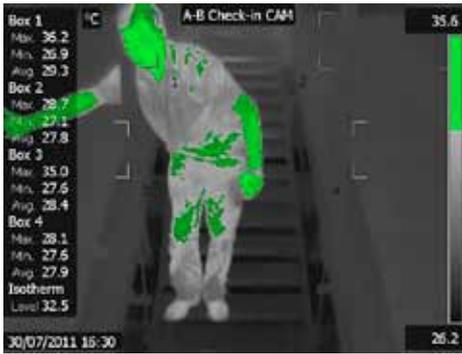
*This test shows that if a certain percentage of an ROI reaches the threshold temperature, for instance due to the wave of an arm, the alarm goes off.*

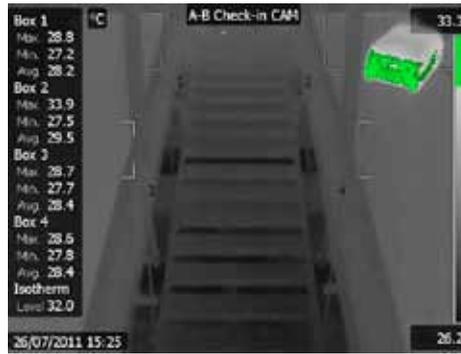
*Suitcases do not trigger the alarm, even if the threshold temperature is reached. The percentage of the ROI that reaches that temperature is too small.*

the conveyor belt stops running every time we try it." According to Türkmen there were a few unwanted alarms in the beginning. "Baggage can heat up in the sun due to warm weather to over 30 °C. These warm bags can trigger the safety system. Fine tuning the settings has helped lower the current unwanted alarm rate to near zero. Even so I would rather have a few unwanted alarms than have one instance where a child remains undetected."

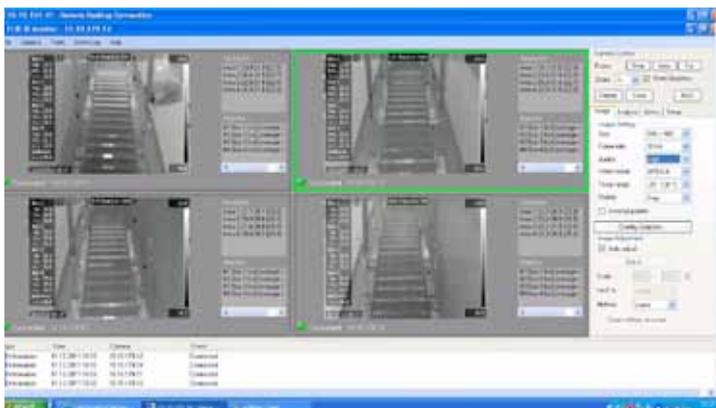
*This screenshot from the FLIR IR Monitor software shows footage from the four FLIR A310 thermal imaging cameras that cover all eight conveyor belts.*

very useful. By fine tuning the settings in the software the amount of unwanted alarms was reduced without compromising the detection performance."
